PRODUCTION TESTING OF Ni-MODIFIED SnCu SOLDER PASTE

Karl Seelig, Timothy O'Neill, Kevin Pigeon & Mehran Maaleckian
AIM Solder
Cranston, RI, USA
kseelig@aimsolder.com

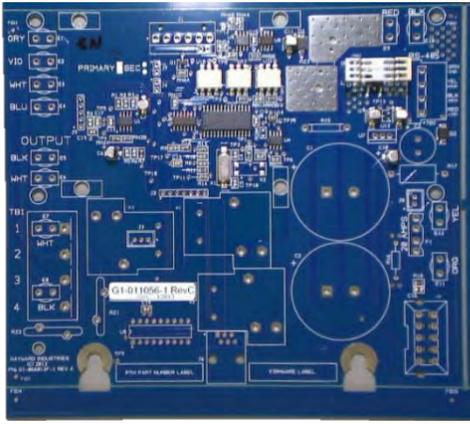
Figure 1a. Controller board used in experimental production run (Case 1a/PCB 1a).

The test vehicles used in these experiments are shown in figures 1a through 2. PCBs 1a and 2 are both industrial controller boards, measuring approximately 6x6" and 8x8" respectively. PCB 1b is a display board that accompanies PCB 1a, and measures approximately 3x3.5."

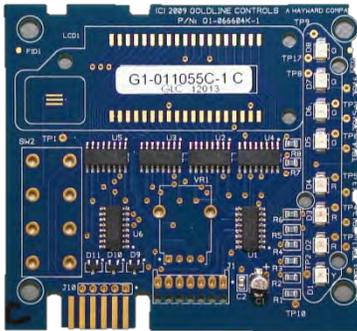
Figure 1b. Display board used in experimental production run (Case 1b/PCB 1b).

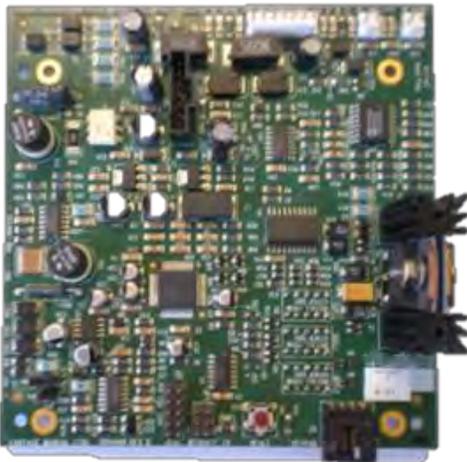
Figure 2. Controller board used in baseline production run (Case 2/PCB 2).

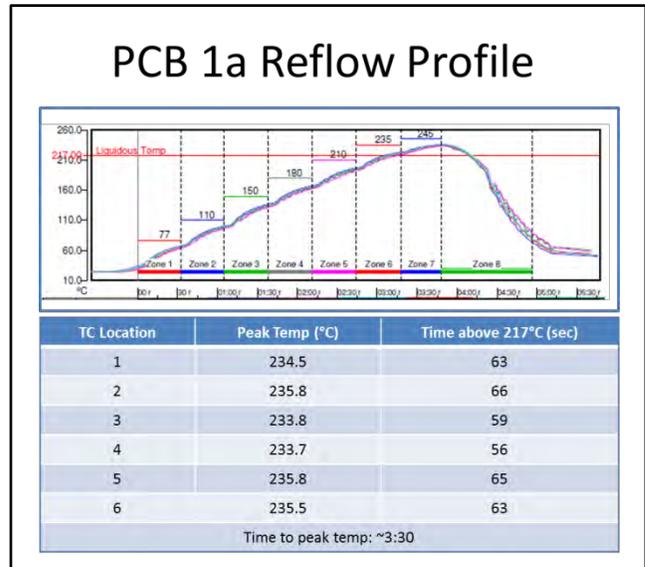
Figure 3. Reflow profile for PCB 1a.

PCBs 1a and 1b ran relatively fast, cool, ramp-style reflow profiles, reaching peak temperatures of 233-236°C in about 3 minutes 30 seconds, with 55-65 seconds above 217°C (figure 3). In contrast, PCB #2 ran a longer, hotter, soak-style profile that peaked at 245°C in 4 minutes 45 seconds (figure 4).

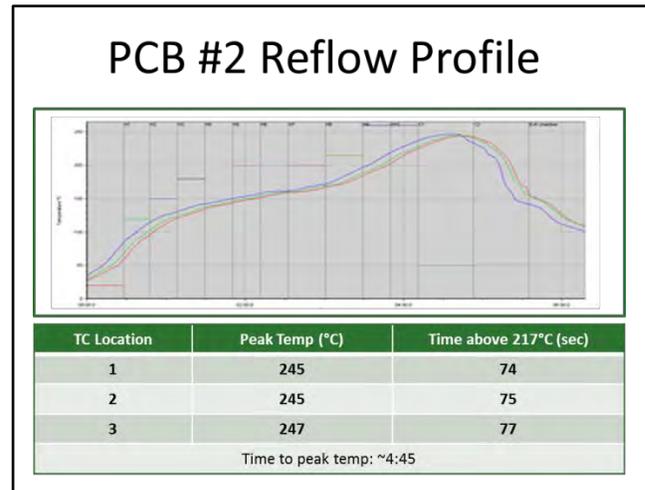
Figure 4. Reflow profile for PCB 2.

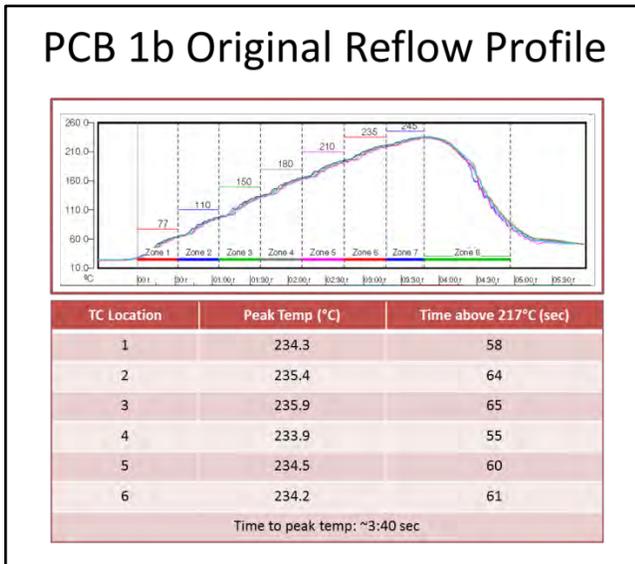
Figure 5. Original reflow profile for PCB 1b

Visual inspection of PCB 1b on its original reflow profile indicated minimal wetting to some of the SOIC leads and a few unmelted solder spheres near areas of higher thermal mass. Maintaining considerations for the thermally sensitive component(s), the profile was modified slightly by slowing the conveyor and increasing one zone temperature. These changes raised the peak temperature to 237°C with an approximate time above 227°C of 60 seconds and demonstrated improved wetting upon visual inspection. The original and modified profiles for PCB 1b are shown in figures 5 and 6.

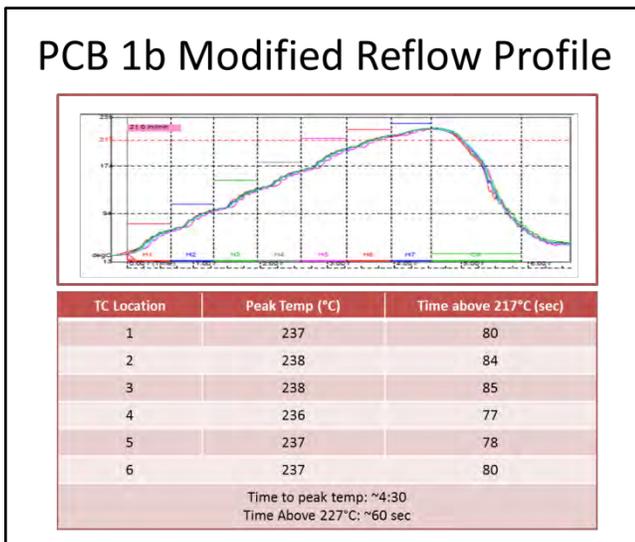
Figure 6. Modified reflow profile for PCB 1b

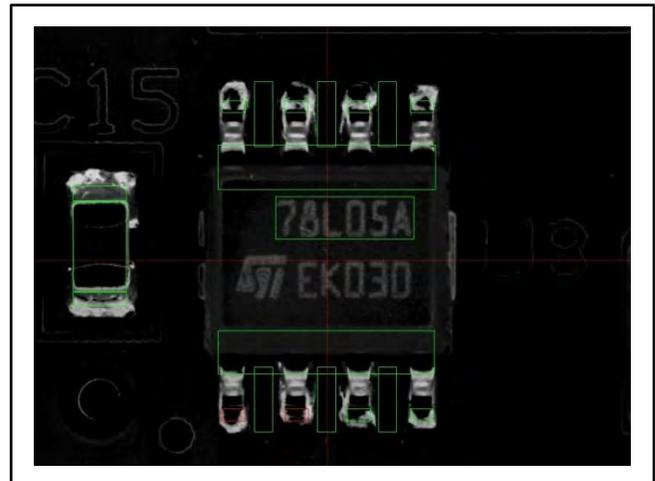
Figure 7. AOI Image of SnCuNi solder joints

Samples of PCBAs 1a and 1b were submitted to Mirtec for additional AOI compatibility analysis. Using the MV-3L AOI system's standard H-V light algorithm (figure 7) very little difference in the reflectivity of the joints was noted. Minor differences were noted when using non-standard horizontal or vertical lighting only (figures 8 and 9).

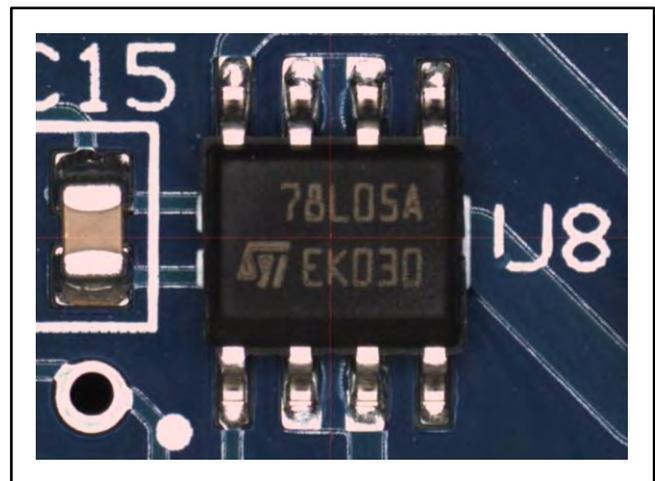
Figure 8. Image of Sn100C solder joints using vertical lighting only

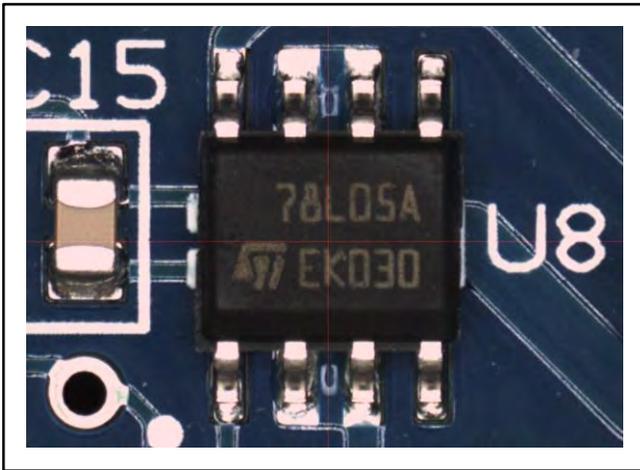
Figure 9. AOI Image of SAC305 solder joints using vertical lighting only.

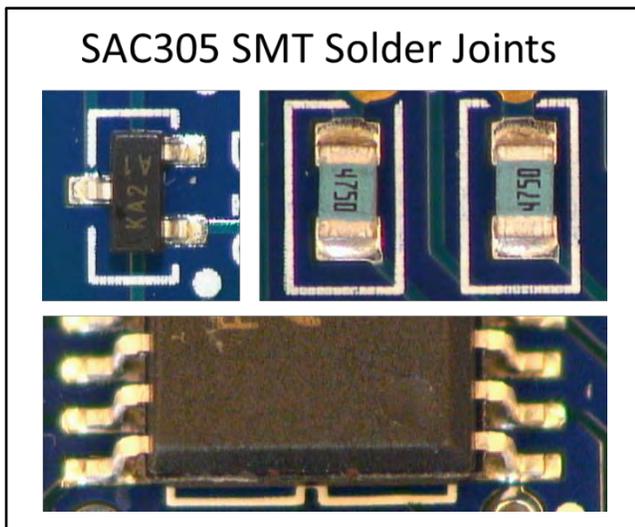
Figure 10. SAC305 solder joints formed in Case 1.

In addition to the professional visual inspection on the assembly line, samples from Case 1 were again inspected photodocumented. Figure 10 shows examples of the SAC305 SMT solder joints and figure 11 shows examples of the same joints formed with the Ni-modified SnCu. While the SnCuNi joints are shinier and smoother than the SAC305 joints, they do not exhibit the typical luster associated with this alloy (figure 12), presumably due to their low thermal exposure during the liquidus phase of the reflow process. Despite their relatively lackluster appearance, they exhibit acceptable wetting throughout the PCB assembly, including areas of higher thermal mass.

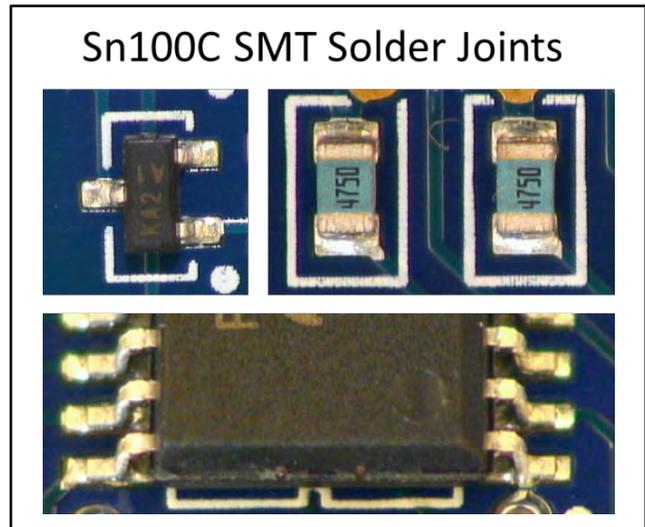
Figure 11. SnCuNi solder joints formed in Case 1.

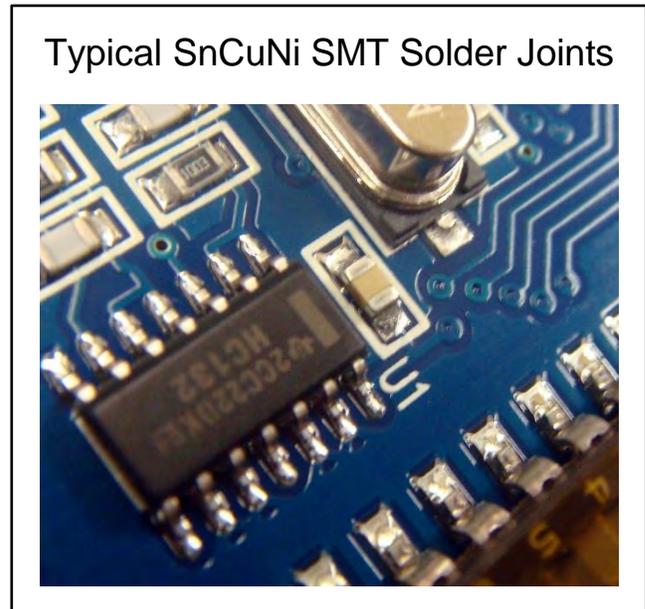
Figure 12. Typical appearance of SnCuNi SMT solder joints

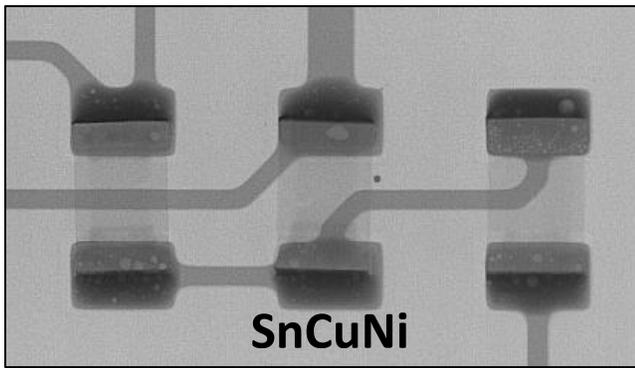
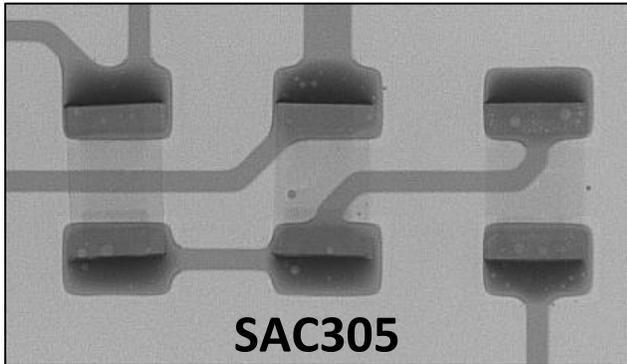
Figure 13. X-ray images of 0805 resistors from Case 1a.

Both SMT and PTH solder joints were inspected by manually operated transmission X-ray. Case 1a was chosen for SMT because the fastest, coolest reflow profile offers the greatest opportunity for voiding. Case 2 was chosen for PTH to allow a performance comparison of the two alloys in wave soldering. Representative X-rays are shown in figures 13-15.

Both solder alloys demonstrated some degree of voiding in the SMT solder joints, but well below the 25% guideline for acceptability. The Ni-modified SnCu alloy showed slightly more voiding in the SMT solder joints of Case 1; the SAC305 showed slightly more voiding in the PTH solder joints of Case 2. It is believed that the level of SMT voiding seen in Case 1 can be reduced by reflow profile modifications that add some soak time in the ramp phase to permit outgassing of volatiles without increasing the ramp rate, peak temperature or TAL dictated by the boards' temperature-sensitive components. The level of voiding in Case 2's PTH components is not addressed because wave soldering of can have varied and multiple causes of voiding, including materials and processes used in PCB fabrication, component manufacturing or PCB assembly.

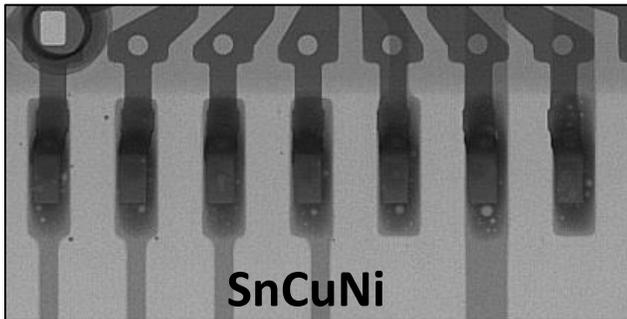
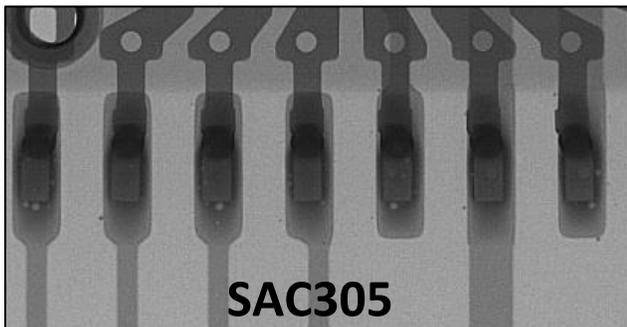
Figure 14. X-ray images of SOIC solder joints from Case 1a.

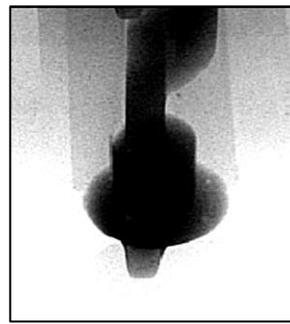
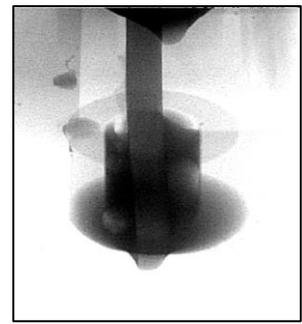
Figure 15. Representative X-rays of both alloys in PTH soldering from Case 2.

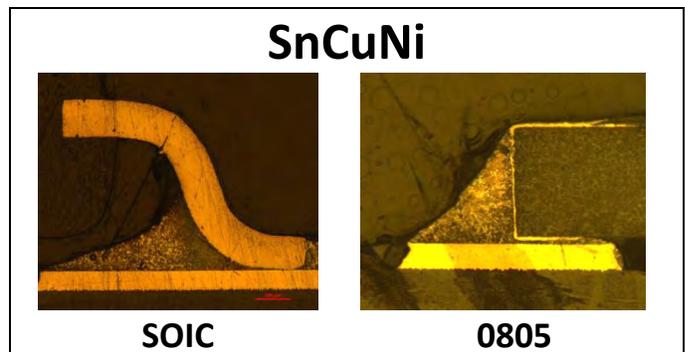
Figure 16. SnCuNi solder joint wetting

Figures 16 and 17 show good solder wetting to gull-wing and end-terminated components for both SnCuNi and SAC305.

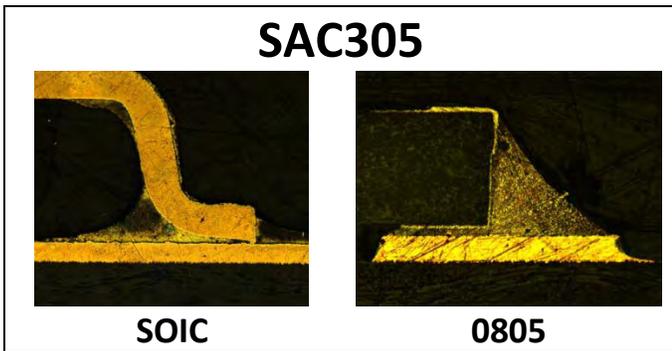
Figure 17. SAC305 solder joint wetting

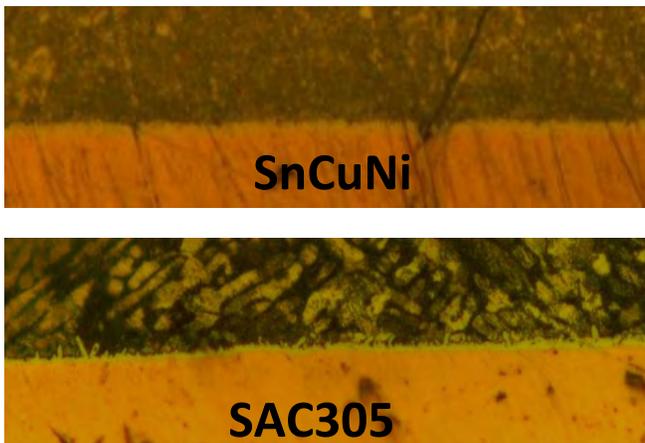
Figure 18. Microstructures and IMCs of both alloys in Case 1.

The SnCuNi joint shown in figure 18 has a continuous, uniform IMC approximately 3um thick. The IMC has a smoother, more nodular appearance due to the nickel that inhibits intermetallic growth. The SAC305 joint also shown in figure 18 also has a continuous IMC approximately 3um thick, but with a more dendritic morphology, possibly complicated by a Ag₃Sn IMC formation. The SnCuNi bulk solder showed a more equiaxed grain structure, whereas the SAC305 showed a columnar grain structure.

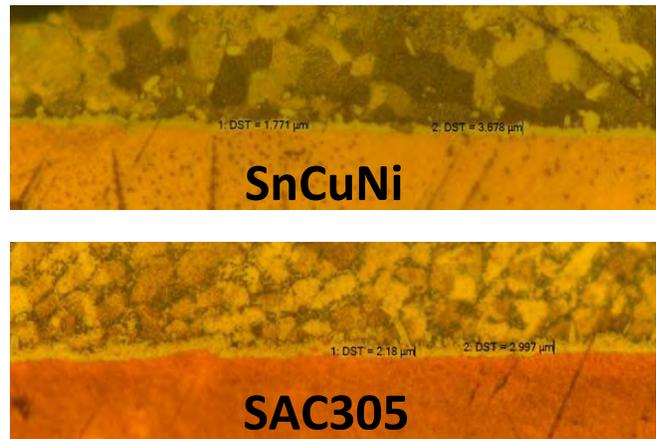
Figure 19. Microstructure and IMC of both solder alloys in Case 1 after aging at 125°C for 96 hours.

The assemblies from Case 1 were aged at 125°C for 96 hours. They were again cross-sectioned and examined via optical microscopy. The grain structures and IMCs are shown in figure 19. Thermal aging had no significant effect on IMC growth.

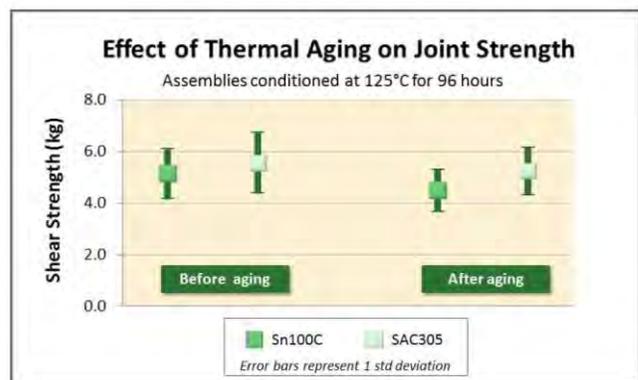
Figure 20. Shear strengths of 0805 resistors before and after thermal aging

Samples from both cases were shear tested. 0805 chip resistors were sheared at 15° angles on a Dage 4000 series shear tester. In Case 1, 16 of each component were tested before thermal aging and 8 of each after. No appreciable differences were noted in overall shear strength, which ranged from 4-6kg, as expected. SAC305 demonstrated slightly higher average shear strength, with slightly larger standard deviations than SnCuNi. The results are shown in figure 20.

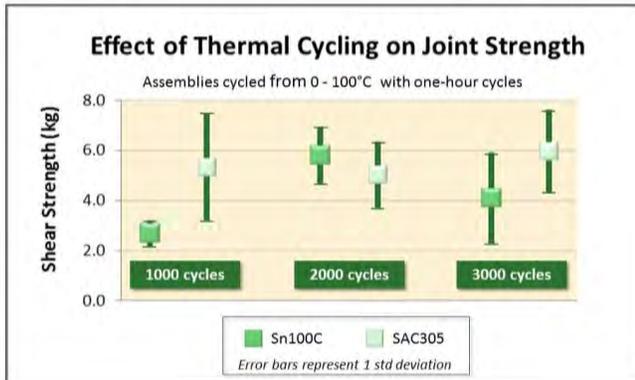
Figure 21. Shear strengths of 0805 resistors after thermal cycling.

In Case 2, 10 components were tested after each of 1000, 2000 and 3000 thermal cycles. Most of the results were also in the anticipated 4-6kg range, with the exception of the SnCuNi at 1000 cycles, which averaged only 3.1 kg (figure

21). The root cause of the low values and small standard deviation in this dataset is unknown. The remaining tests at 2000 and 3000 cycles produced results in the expected ranges.
