# IDENTIFYING SOLDER MASK PROBLEMS WITH SIMPLE TESTS

# BY TIMOTHY O'NEILL

#### ORIGINALLY PUBLISHED IN CIRCUITS ASSEMBLY

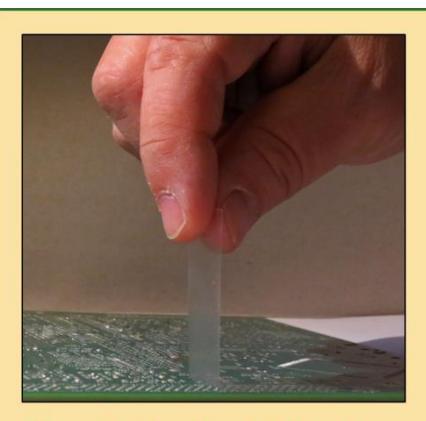
#### FIGURE 1.

Tape Test for Mask Adhesion Press at least 2" of adhesive tape to the solder mask and peel back at 90 degrees. The tape should not remove any of the mask.

This test involves applying a piece of transparent adhesive tape of at least 2 inches in length. Press the tape on the board and pull it up quickly at an angle approximately 90 degrees to the PCB surface (Figure 1). If the tape pulls the mask off, you are looking at an adhesion problem. The official IPC test method (2-4-28) calls out 3M Brand 600 ½ inch (aka "Scotch") tape, but if that's not what's in your dispenser, use whatever is there.

If the mask lifts, observe the condition of the copper underneath. If the copper is shiny, it was likely not properly prepared for solder mask application. A matte finish indicates proper cleaning and roughing of the surfaces before mask application.

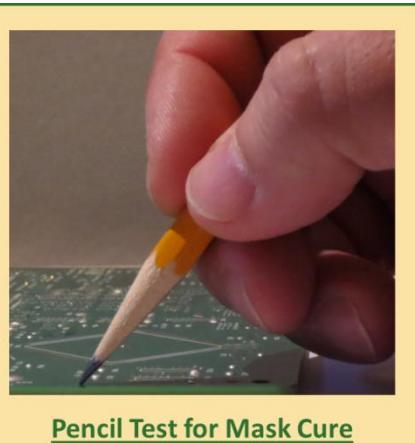
#### FIGURE 2.

Use a pencil to push on the solder mask at a 45 degree angle. The pencil should not gouge or damage the mask.

**The Pencil Test:** Locate a wooden pencil and give it a fresh sharpening. Hold it at a 45° angle and press firmly away from you (Figure 2). If the solder mask lifts or gouges, it is not sufficiently hard. This may be the result of improper curing or insufficient hardener added to the mask before curing.

The pencil you used was likely a #2H (we're all familiar with those from standardized tests). Pencils are graded on a hardness scale, and any graphite graded less than #6H should not gouge solder mask. If you want a #6H, or a complete kit of varying hardness pencils, they are sold at art supply stores.

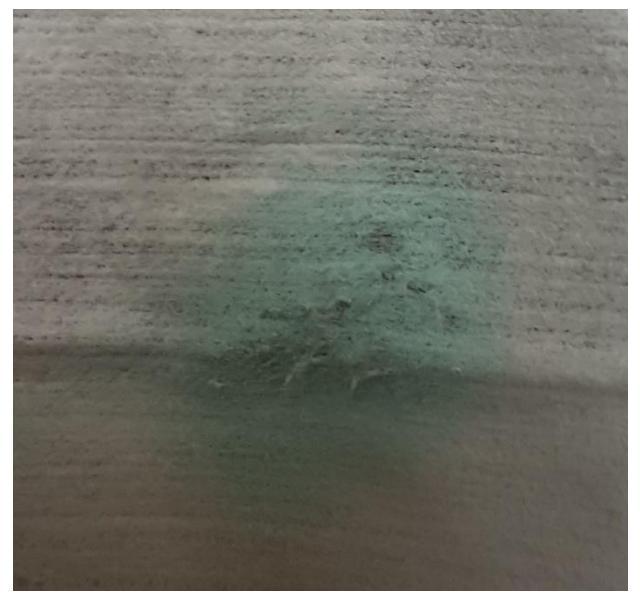
**FIGURE 3.** Greenish color deposited on a Solder Mask Check Wipe indicating a solder mask curing problem.

**Solder Mask Check Wipes:** <u>BLT Circuit Services</u> <u>offers easy-to-use Solder Mask Check Wipes</u>. These wipes are designed for a quick qualitative test to identify under-cured solder mask on PCBs. To use, remove a wipe from the package, ensuring the package is re-sealed. Rub the wipe on the PCB with moderate pressure for about 10-15 seconds in various areas.

If the solder mask is under-cured, color from the resist will transfer onto the wipe, indicating issues with the mask's adhesion or curing (Figure 3.). If such a transfer occurs, it suggests the PCB may have defects and should be reported to the supplier for correction.
